# Turbine drive train and generator overhauls showcase local capacity

## The Ingula pump storage repair

## Motor rehabilitation keeps Zambian mine pumping

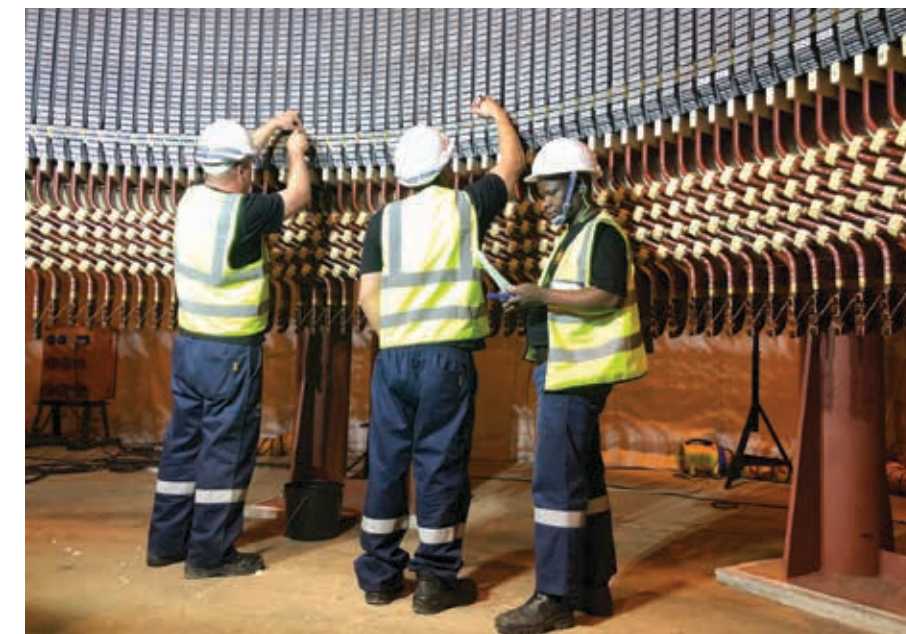
In what has been described as the largest winding installation ever conducted in South Africa, Marthinusen & Coutts has completed a major repair at Eskom's Ingula pumped storage hydro-electric plant. The contract involved the complete rewind of a 373 MVA stator for one of Ingula's four 14-pole motor generators.

The contract involved the complete rewind of a 373 MVA stator for one of Ingula's four 14-pole motor generators. According to Richard Botton, managing director of Marthinusen & Coutts, the 342 MW unit is among the biggest in South Africa with a core diameter measuring 5.0 metres, a core length of 3.2 metres and a rotor mass of 500 t.

"As the stator was located deep in the turbine floor, all the winding was required to be conducted on site," says Botton. "In this complicated repair, each replacement coil set was fitted, connected and brazed on-site from pre-manufactured and pre-packed

components supplied by the OEM. The most painstaking process, conducted to the highest standards, was the resistive brazing on 1 824 joints."

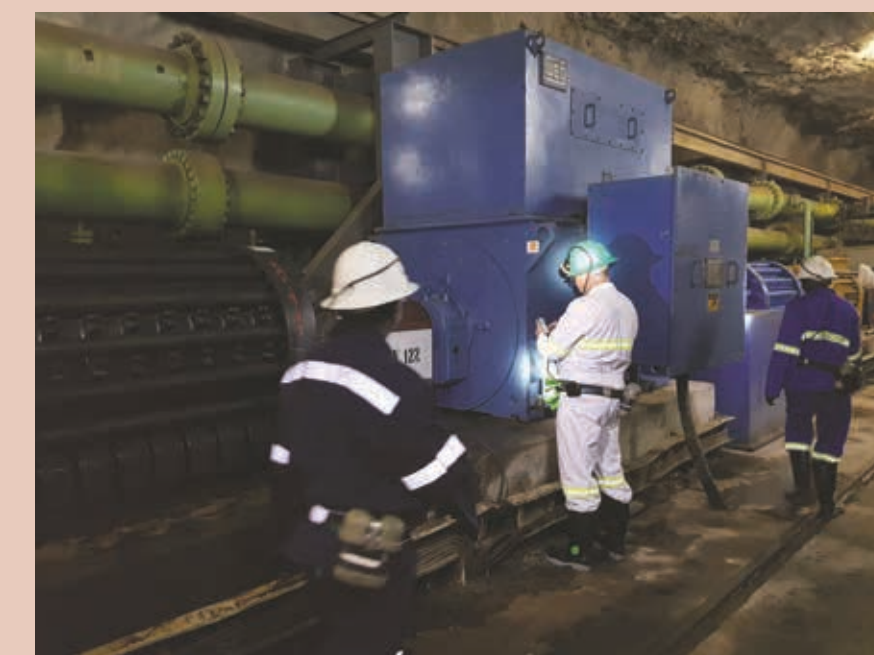
Marthinusen & Coutts technical personnel monitoring the condition of a 3 300 kW pump motor in Zambia at one of the wettest mines in Africa.

Investigations revealed that the motors driving the pumps were in a poor condition, severely affecting the availability and the performance of the pump chambers. This required the initiation of a detailed refurbishment programme, involving the procurement of spare parts, the setting up of an on-site bearing store, and taking the lead in returning the motors to full service.

Where possible, the motors were repaired in situ – thus avoiding any possible crisis of underground flooding – while others were removed for full refurbishment. The highest levels of engineering practices were followed during repairs, re-installation and commissioning.

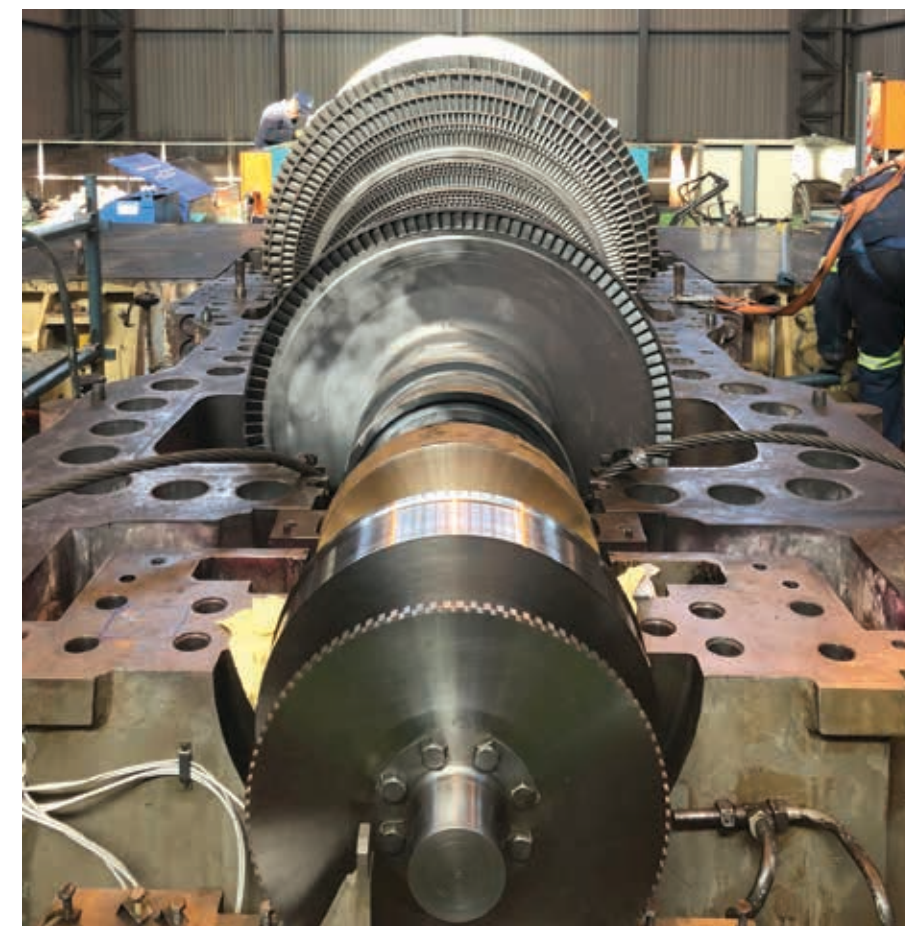
Marthinusen & Coutts took full responsibility for the entire drive train refurbishment on a 70 MVA generator set for the electrical generation plant at Metalloys' manganese plant in Meyerton, Gauteng.

The scope included a complete inspection of the turbine rotor and internal components, as well as runout and dimensional inspection on the rotor. Inspections incorporated glass bead blasting and non-destructive testing of many components.

High-speed balancing of the 13 t rotor was conducted, and turbine rotor journals

were repaired. White metal bearings were relined and the thrust bearing was modified to improve fitment in the bearing casing. Positive material identification tests were conducted on all the studs, nuts and shaft seals. A complete 3D scan was done of the centreline to allow reverse engineering drawings.

At its repair facility in Cleveland, Johannesburg, Marthinusen & Coutts also performed a number of inspections, tests and repairs on the rotor. Dimensional inspections and electrical tests were conducted, as well as non-destructive testing such as phases array ultrasonic testing. Slip rings were ground, the diode wheel was inspected, and the diodes were tested.
