High impact laser metal deposition refurbishments for critical power equipment

Mark Newby of Eskom Research, Testing and Development, and Corney van Rooyen of the CSIR's National Laser Centre talk about the longstanding bilateral collaboration between ESKOM and the CSIR on high impact refurbishment projects, including the repair of PTR-tanks in the nuclear industry, a laser metal deposition tenon re-build on turbine blades, and other turbine rotor, blade and understrap repairs.

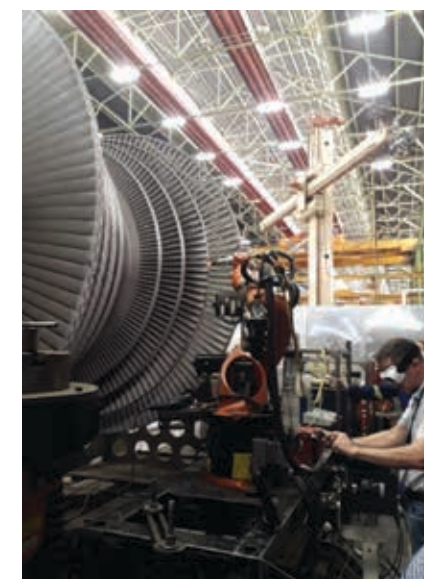
Above: A laser based repair being done on a turbine blade shroud of a low pressure turbine.

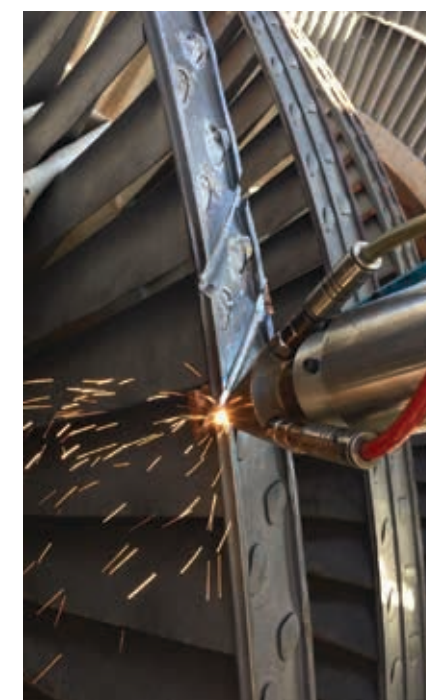
Right: An initial test in progress on turbine blade shroud.

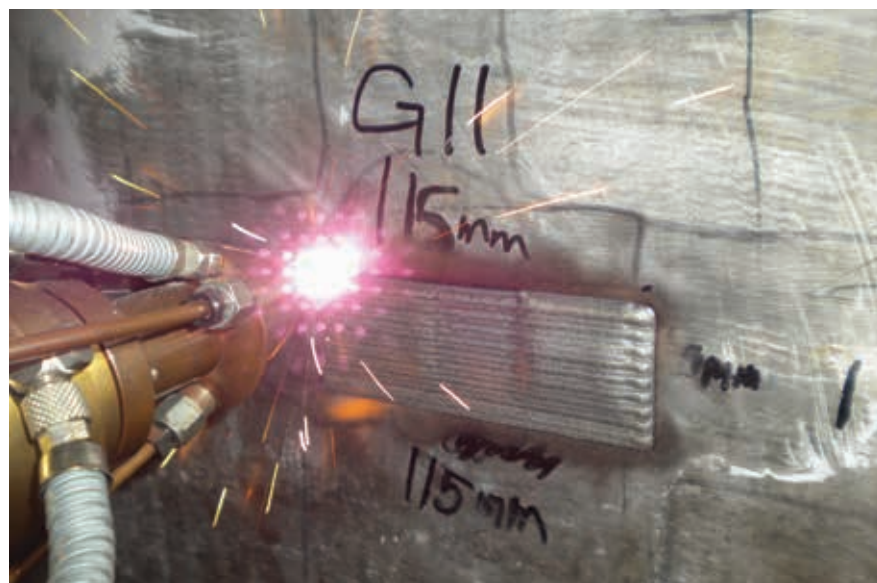
On the two Koeberg PTR tanks, a laser-based welding technique was used to seal leaking ASCC cracks before using a powder filler to build up and reinforce the surface area.

corrosion cracks (ASCC) along the welds of the PTR cooling water tanks at Koeberg nuclear power station. We explored the use of friction stir welding with the guys at Nelson Mandela University (NMU) and laser weld repair with CSIR's NLC.

"At the same time, we were working with Corney on a powder-fill laser welding technique to do the same job. With the laser, we were able to seal leaking ASCC cracks before using a powder filler to build up and reinforce the surface area," says Newby, adding that the laser technique was preferred and the two Koeberg PTR tanks were repaired in 2011 and 2012,

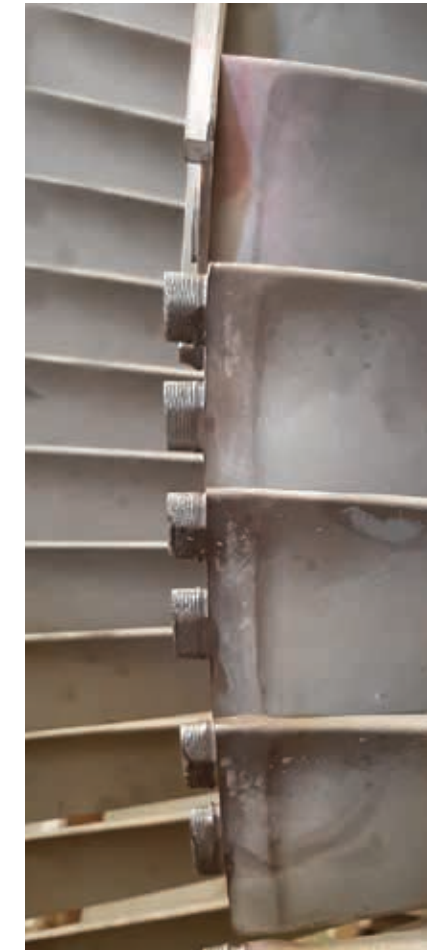
Above: A completed *in-situ* turbine blade understrap replacement after the rebuilt tenons have been peened.

After a full field trial, the qualified tenon refurbishment process was applied to an *in-situ* understrap replacement on a 657 MW Majuba low pressure steam turbine in January 2020 at ESKOM-owned Rotek Engineering. Tenons on ten blades, five blades either side of the understrap, were removed. The two half shroud sections either side were cut after blade five, enabling them to be removed. The tenons were refurbished using laser metal deposition to near net shape before being hand-dressed. Following inspection and heat treatment, the understrap was replaced, followed by fitment, weld-joining and heat treatment of the removed shroud sections on either side. The repair was then completed by peening the tenons to firmly hold the turbine blades in place.

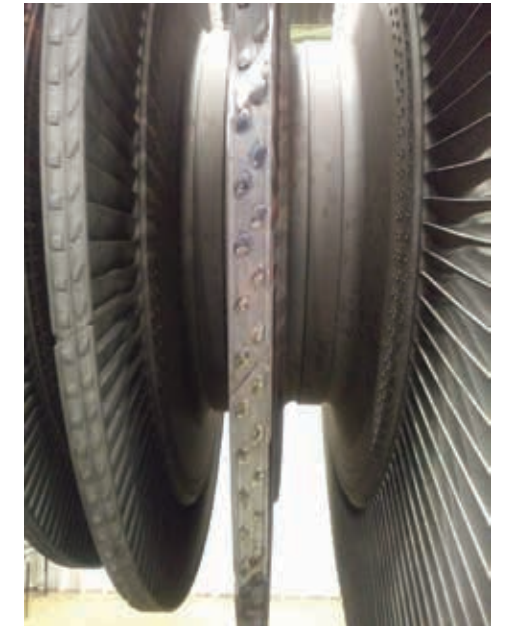
Left: As welded turbine blade tenons.

With a typical near net shape profile of 10 by 10 with a 6.0 mm height for the shroud-only tenon connection and 9.0 mm for the tenons passing through both the shroud and understrap, Van Rooyen and his team chose to use a 2.0 kW IPG Photonics Fibre laser for the *in-situ* rebuild. "IPG fibre lasers offer good beam quality and high power, but they are compact and very robust," he tells *African Fusion*.

A small Kuka robot was chosen to manipulate the laser via a fibre optic and the powder through a nozzle to rebuild the tenons. "The robot was programmed to build a near net shape profile from a pre-defined tool path. All we had to do onsite was reference the starting point for each tenon. We could also easily reprogram the tool path for other tenon sizes, which were different depending on the location and stage of the turbine blade on the turbine," Van Rooyen adds.
