Rock breaker rebuild

Sandvik Rock Processing has completed a full OEM-standard refurbishment of a Sandvik BR3288i hydraulic breaker and a Sandvik BB8094R breaker boom for a major gold mine in Ghana, restoring a critical asset in the primary crushing circuit, significantly improving uptime and production.

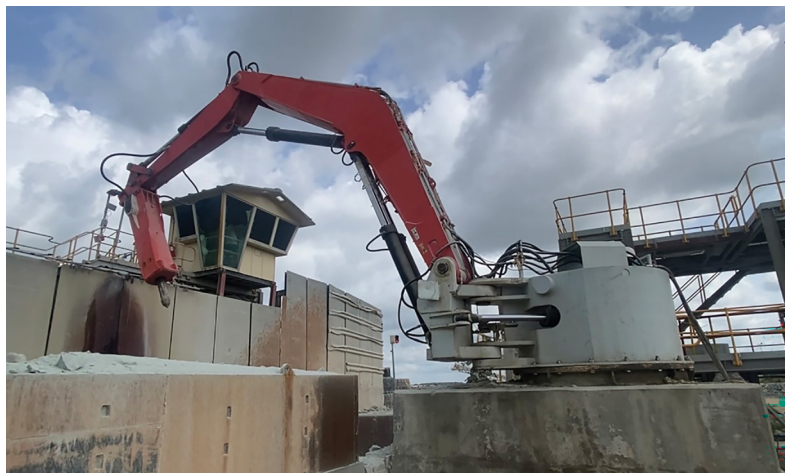
Left: Installation of the refurbished Sandvik BR3288i hydraulic breaker and BB8094R breaker boom has been completed, and the unit is now ready for testing in the primary crushing circuit. **Right:** Coupling of the main boom to the pedestal is underway as part of the Sandvik rock breaker installation.

After the rebuild was completed, Sandvik Rock Processing returned to the site to install and commission the breaker. The three-week process required close coordination between Sandvik Rock Processing and the mine to manage crane access, electrical connections, equipment positioning and safety protocols.
