Approaches to managing corrosion under insulation

Corrosion Under Insulation (CUI) presents an ongoing, significant and costly challenge to processing industries, and still makes up a large percentage of global maintenance expenditures. President of EonCoat Merrick Alpert explains some approaches to better manage corrosion and its accompanying costs.

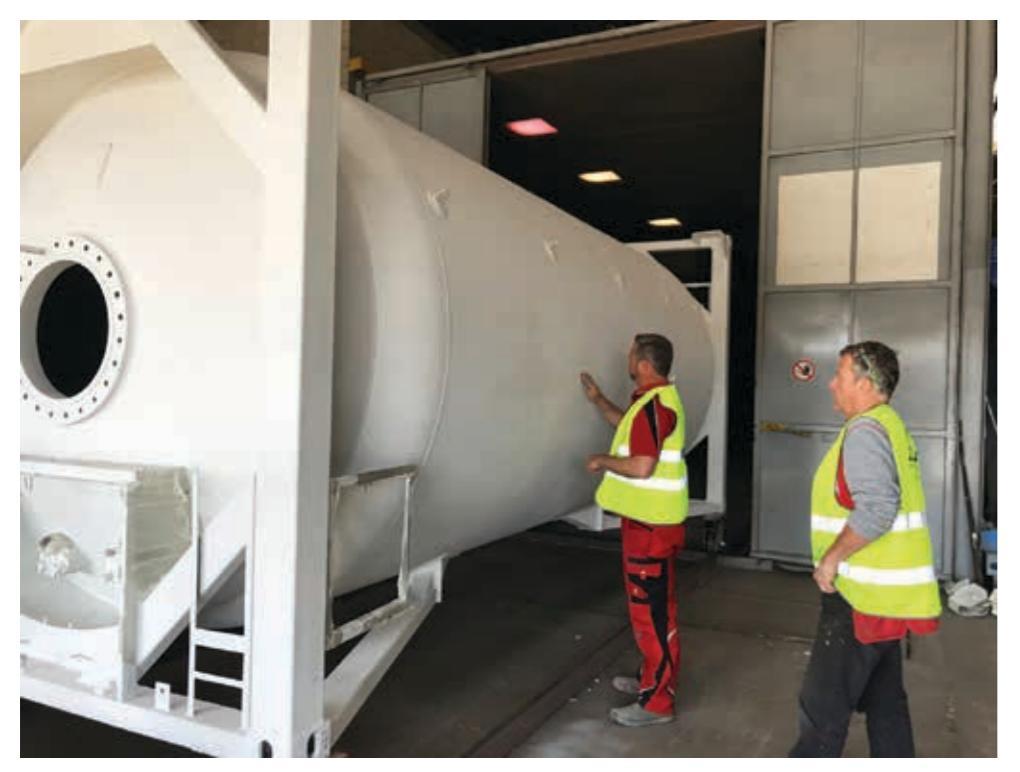
EonCoat conducts training and certification for all applicators, which is typically completed in one day.

The EonCoat formulation is 100% solids, water-based, non-toxic, non-flammable, odourless, and has zero volatile organic compounds (VOCs) and hazardous air pollutants (HAPs). It can be applied at temperatures ranging from 5-50°C and humidities of 30-95% at a minimum thickness of 0.5 mm, with no upper limit. Acrylic, epoxy, and polysiloxane coatings have all been used as topcoats for the ceramic CBPC coating. EonCoat conducts training and certification for all applicators, which is typically completed in a day.

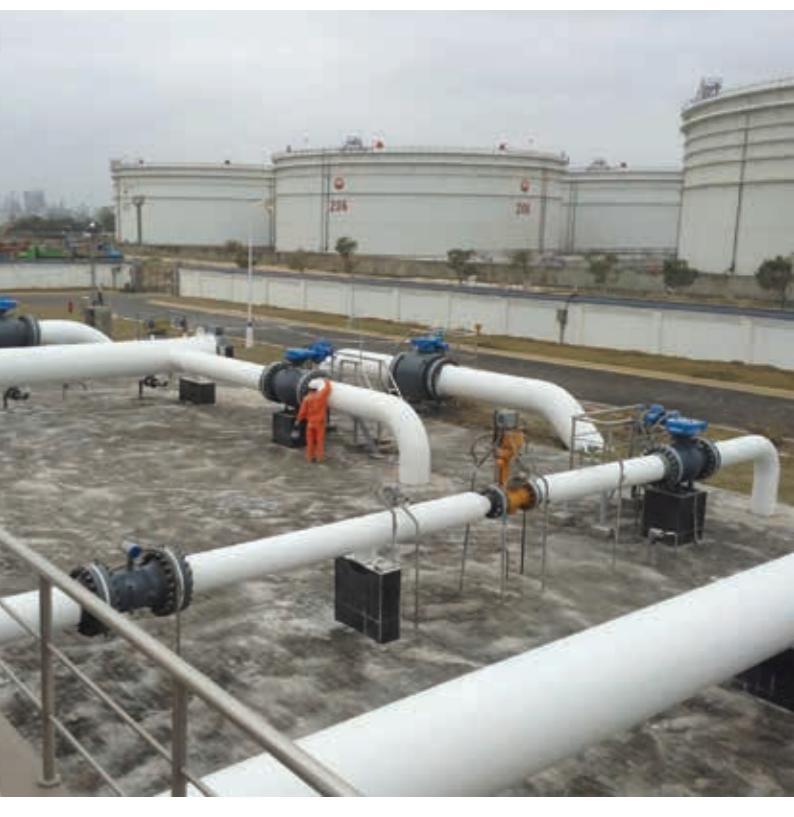
Left: Scratches, chips, and even tiny pinhole defects allow sufficient ingress of water and chemicals that can lead to corrosion. Right: Anti-corrosion coating for gas

As a preventative measure, polymer-based epoxy, polyurethane, and siloxane-based coatings are widely used for corrosion prevention. These types of coatings, however, only provide protection as long as they remain unblemished. Scratches, chips, and even tiny pinhole defects allow sufficient ingress of water and chemicals that can lead to corrosion. Once the coating is breached, it – and the insulation on top of it – can trap the water and any chemicals that promote corrosion, leading to CUI.
